A Guide To Dating Morbier Clocks

by Ken McWilliams

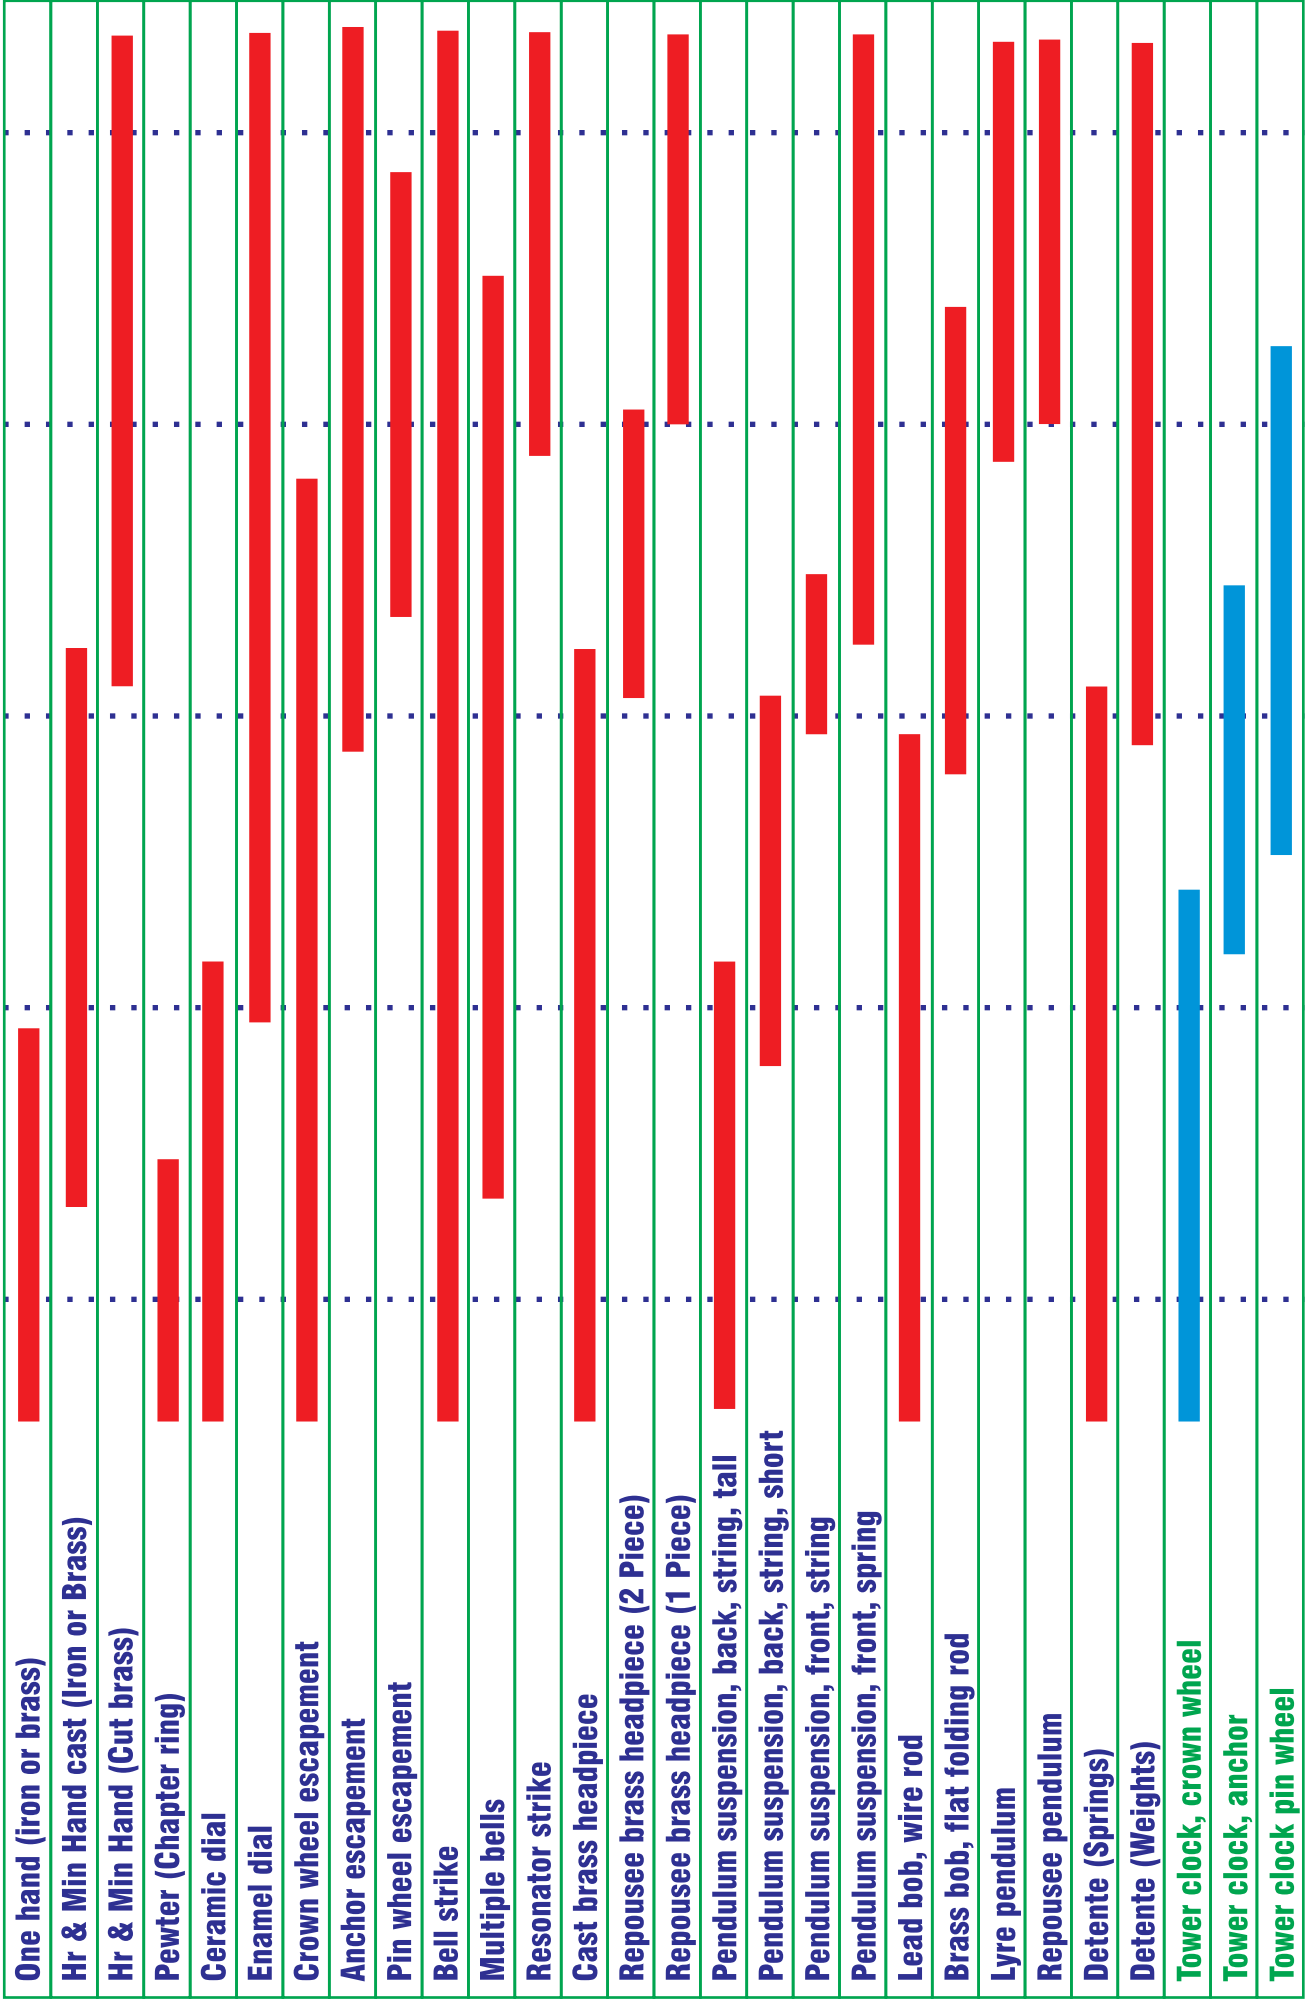
1680 1700 1750 1800 1850 1900 1930

By using the attached Morbier Time Line and applying a little detective work, you will be able to make a very good educated guess as to when the clock was made; much better than most of the exaggerated dates that I see on eBay and at the marts.

There are hundreds of other indicators for dating the Morbier clock but if you study the time line and use some logic, you will be able to come very close to determining it's age.

The data in the Morbier time line was determined after researching many articles, books, websites and conversations with collectors. It is a work-in-progress because there are many conflicts and disagreements among some of the experts in the field. I will continue to update it as I find more reliable information.
